TECHNICAL REPORT REMR-CO-3

CASE HISTORIES OF CORPS BREAKWATER AND JETTY STRUCTURES

Report 2
SOUTH ATLANTIC DIVISION

Francis E. Sargent

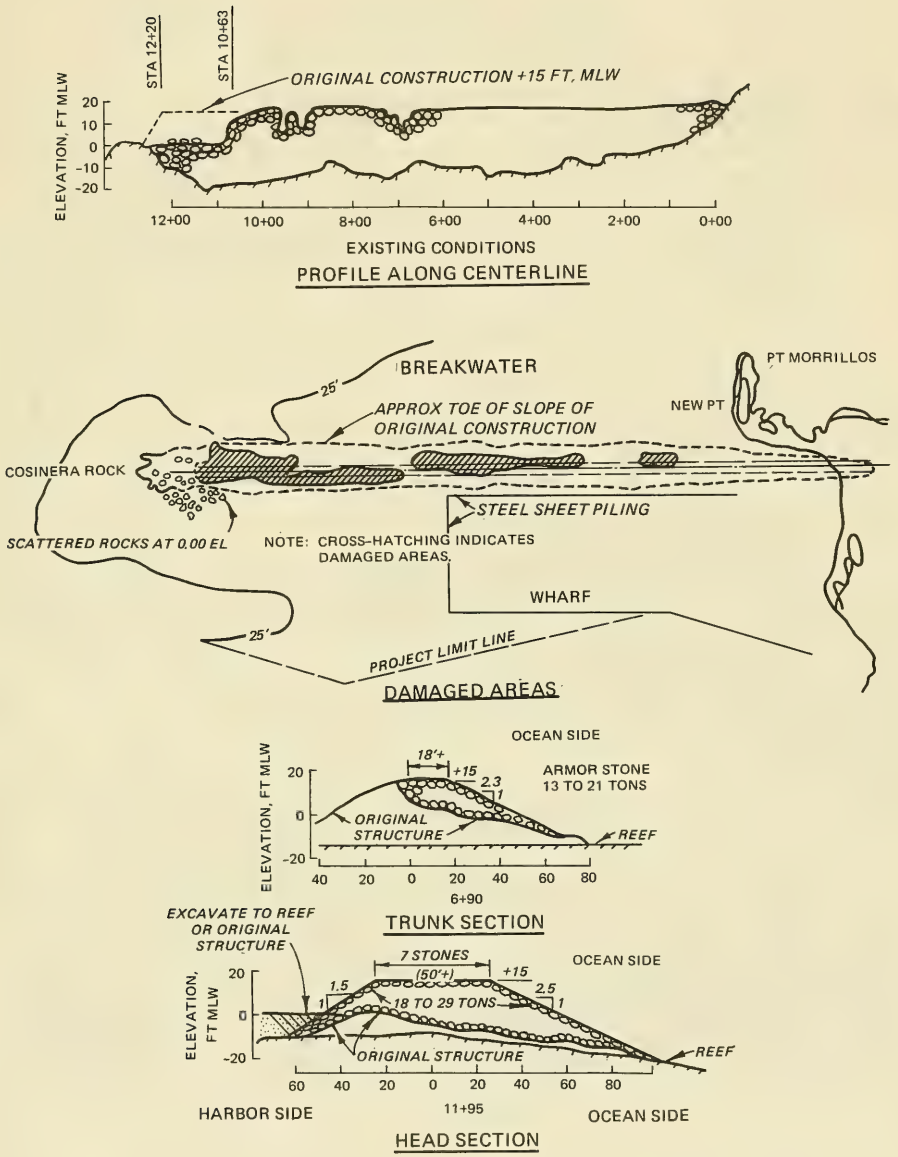
Figure 42. Arecibo Harbor existing damage prior to 1984 repairs and typical repair sections

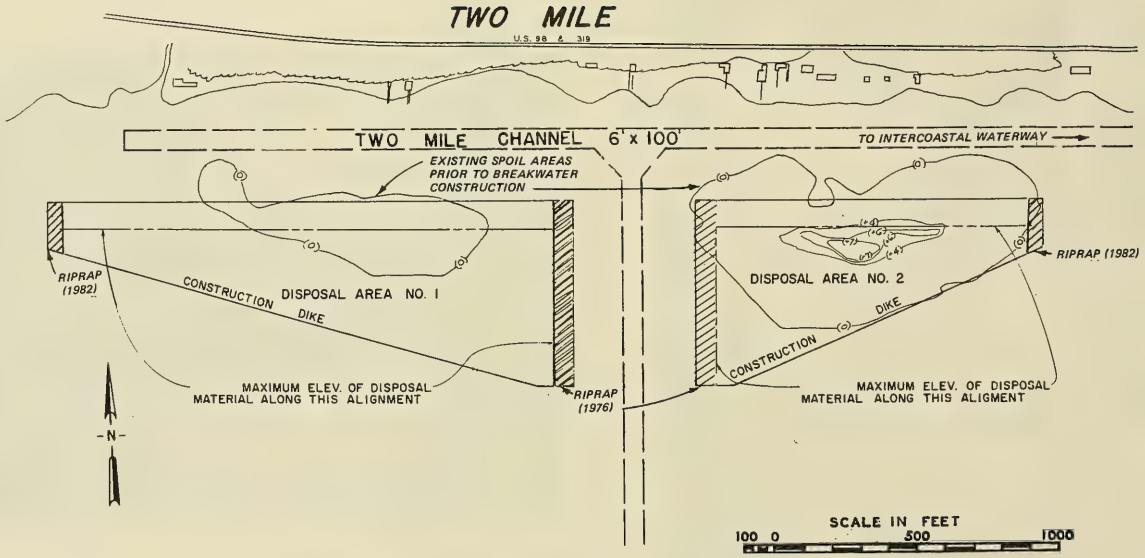
Figure 45. Two Mile breakwaters, Florida

1982	The outer ends of the two breakwaters had been eroding and were revetted with stone left over from the original construction.
1985	The breakwaters are presently in good condition.

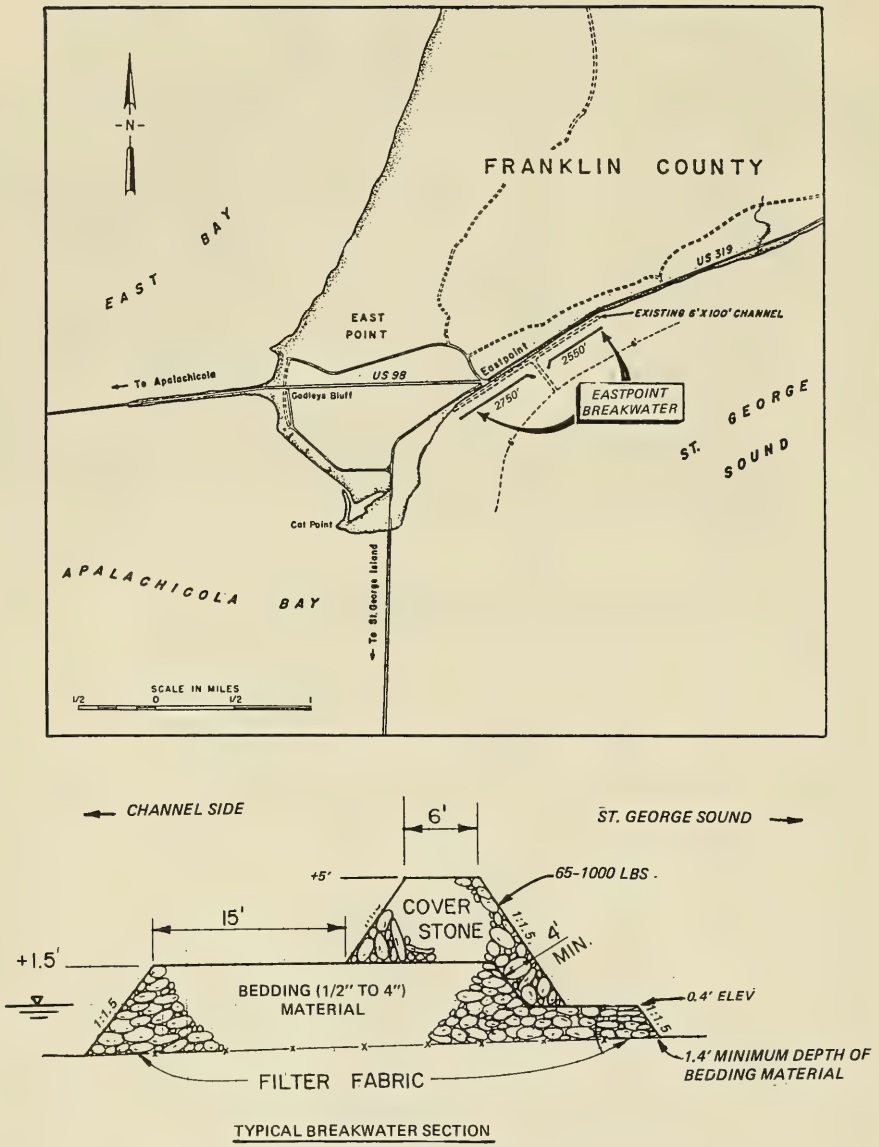
Figure 46. East Point breakwaters, Florida

1985	The structure was in excellent condition, and plans to extend its length were being considered.

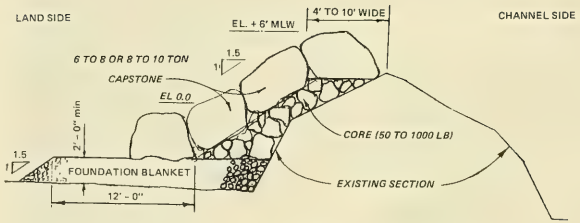
Figure 49. 1962 repairs to jetty wings at Panama City

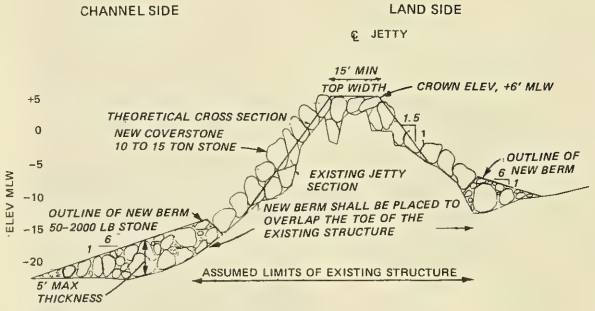
Figure 50. Typical 1966 west jetty repair section at Panama City

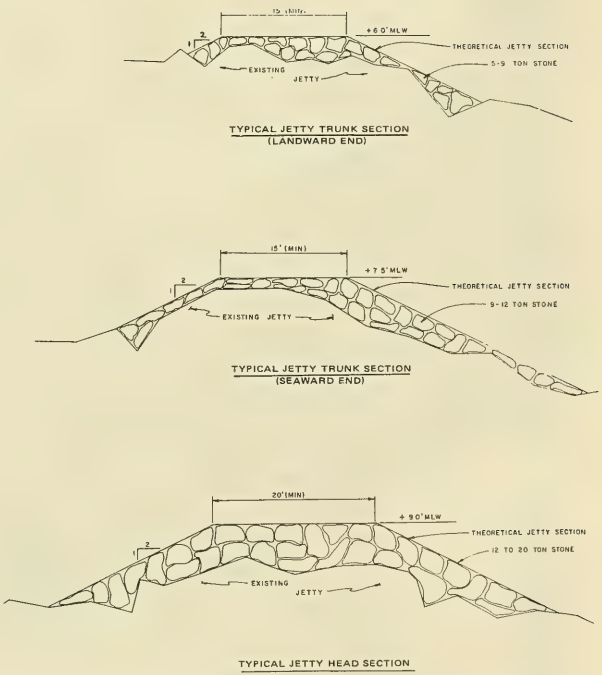
Figure 51. Typical 1984 repair sections of the east jetty at Panama City

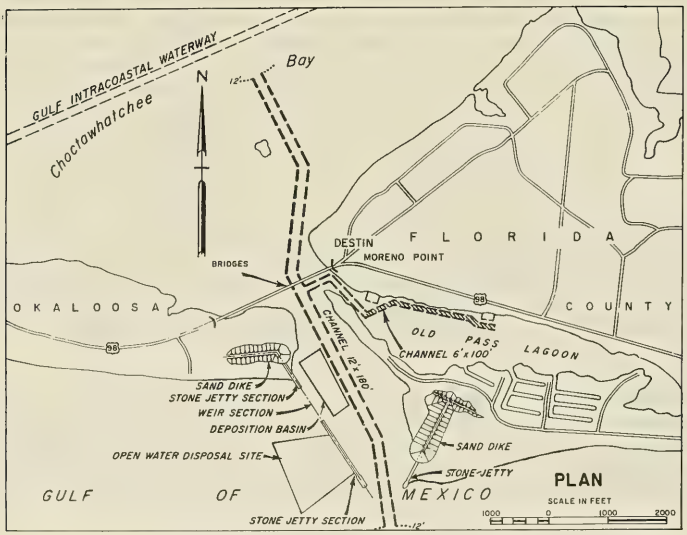
Figure 53. East Pass, Florida

Date(s)	Construction and Rehabilitation History
1982 (Cont)	providing for insufficient impounding capacity. Shoaling in the vicinity of the weir apparently resulted from inadequate maintenance of the deposition basin, which had only been dredged once (287,000 cu yd removed in 1972). The report recommended closing the weir section of the west jetty since the net littoral drift was, in fact, from east to west to reduce the shoaling in the inner channel areas caused by westward littoral drift passing through the weir section.
1985	The weir section of the west jetty was modified with the placement of a rubble-mound trunk section identical to the trunk section used in the original design (except that the blanket stone was to have a minimum thickness of 1 ft directly over the sheet piles and 2.5 ft thick elsewhere as called for in the original design). Estimated volumes of blanket, core, and cover stone were 5,300, 1,500, and 4,600 cu yd, respectively. At present, toe stability problems exist and have been documented with video footage of scour along the toe of the east jetty. Otherwise, the jetties are in good condition.

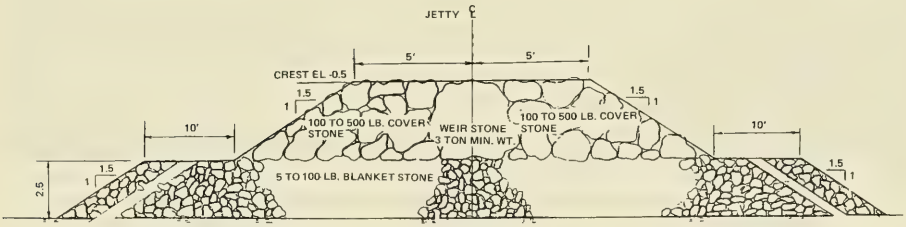
Figure 55. Design cross section of 1970 modification to the weir section of the west jetty at East Pass

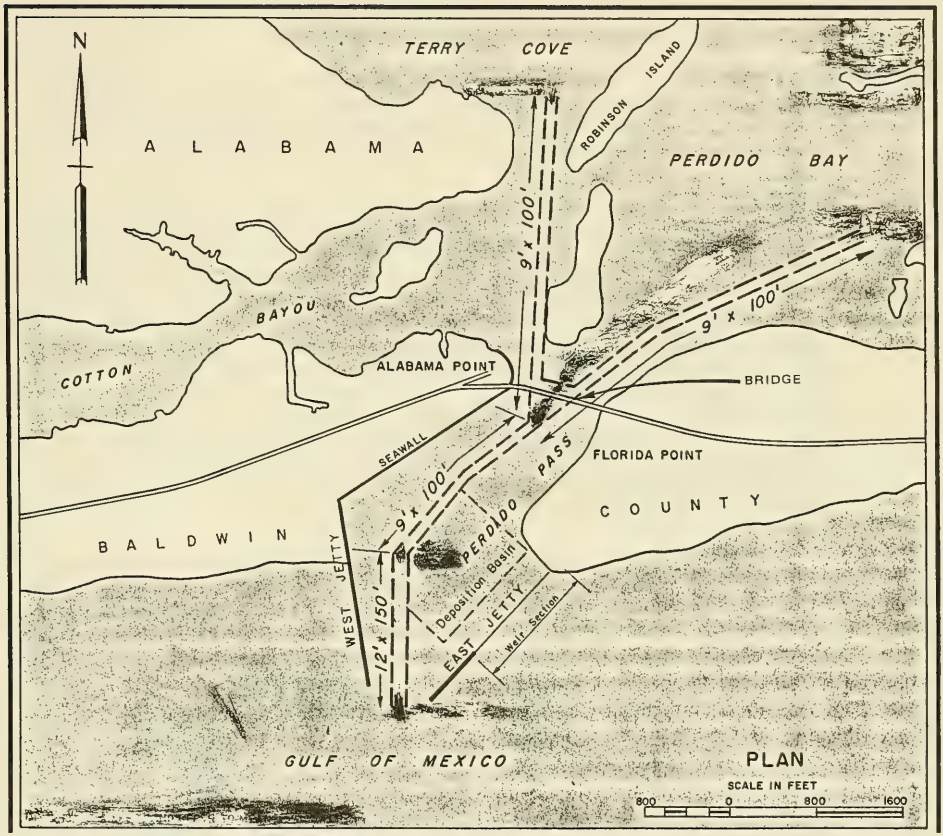
Figure 56. Perdido Pass, Alabama

1972	A SAM report on the weir jetty (prepared for CERC) indicated that the deposition basin had filled to capacity during the first 2 years. The pattern of filling indicated that in addition to the westerly littoral drift material sand movement on the ebb tide was interrupted and collected in the basin. Subsequent encroachment of additional material into the navigation channel indicated the need for prompt dredging of the deposition basin on a regular basis.
1974	The rubble-mound sections of both jetties were rehabilitated to bring them up to design cross sections. A field survey taken prior to the rehabilitation showed substantial losses of material on both jetties. Crest elevations on the east jetty were (a) inner 75 ft at +0.5 ft mlw, (b) the next 200 ft from +3 to +5 ft mlw, and (c) the remainder (including the head section) within ±1 ft of the design elevation of +6 ft mlw. The entire west jetty appeared to have undergone a substantial loss of bedding layer (it was 5 to 10 ft wide) and cover stone on the channel side when compared to the design cross sections (no previous survey data found). The crest elevations on the trunk section varied from 0 ft mlw to +5 ft mlw, and the head section crest elevations were at or above the design elevations.

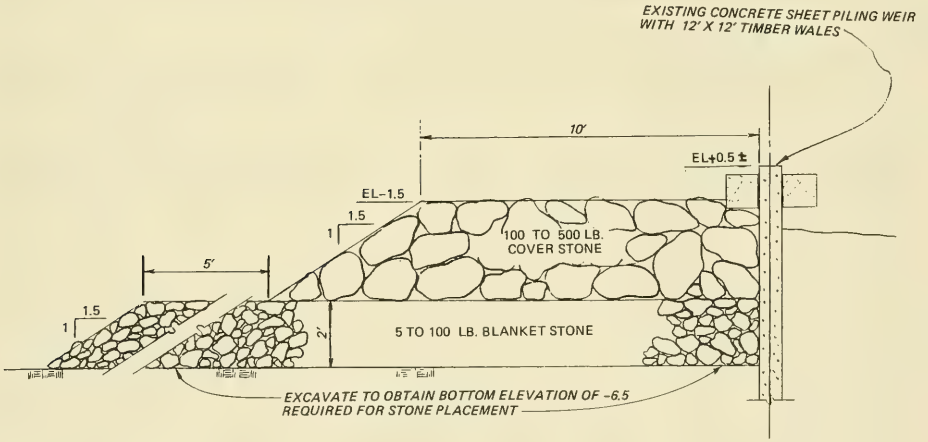
Figure 58. Design cross section of 1970 modification to the east jetty weir section at Perdido Pass
